Dual-View Imaging Report

123 Anywhere St
Somewhere, Ohio 12345

Date:6/29/05
Time:4:19
Ambient Temperature:87* F
Wind Speed:2.6 mph
Relative Humidity:80%

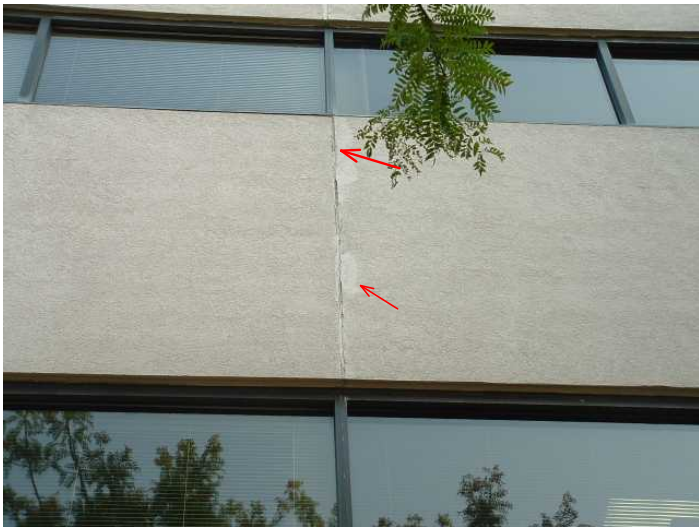
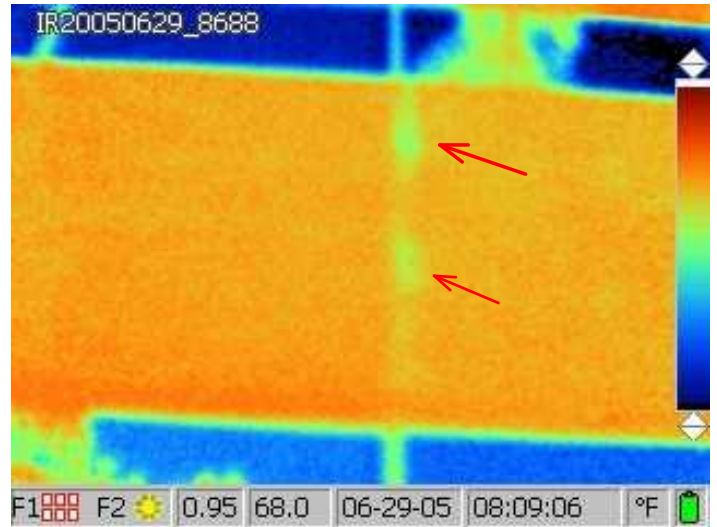
Observations:
Moisture penetration noted at vertical control joint in EIFS exterior finish system as indicated with EZmark arrows

Location:Exterior - Orientation:Southeast - Delta Temperature:20 degrees
Equipment: ThermalScan IRC-3000
Problem: Moisture penetration noted at vertical control joint in EIFS exterior finish system as indicated with EZmark arrows

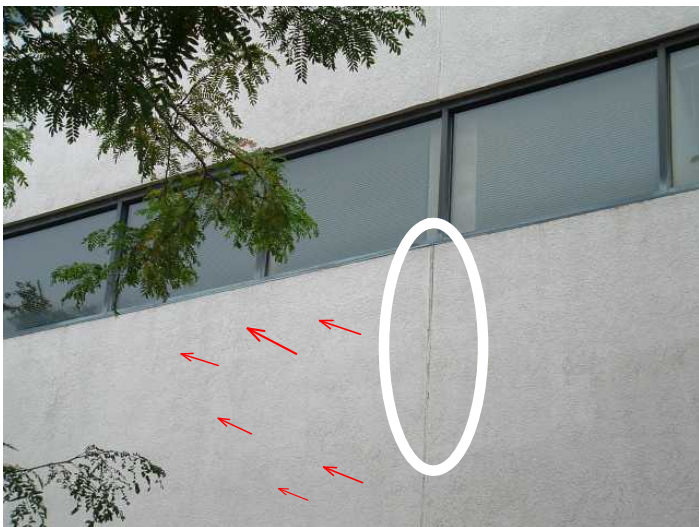
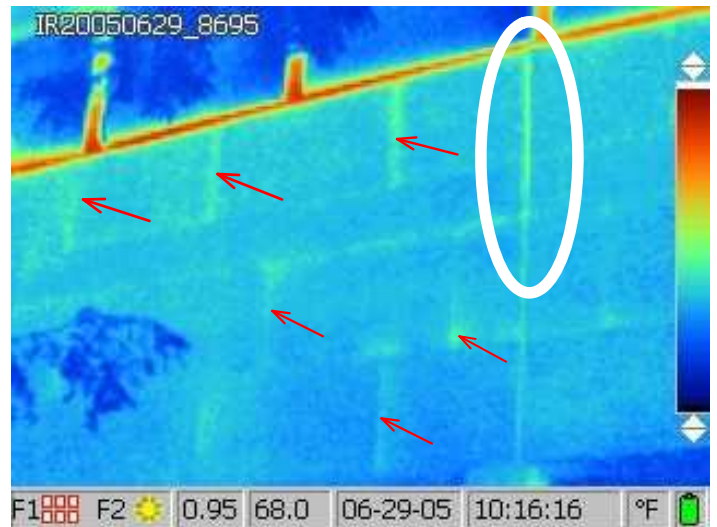
Observations:
Moisture detected at control joint as called out with EZellipse marking, air infiltration as called out using EZarrows

Location:Exterior - Orientation:Northeast - Delta Temperature:30 Degrees
Equipment: ThermalScan IRC-3000
Problem: Moisture detected at control joint as called out with EZellipse marking, air infiltration as called out using EZarrows

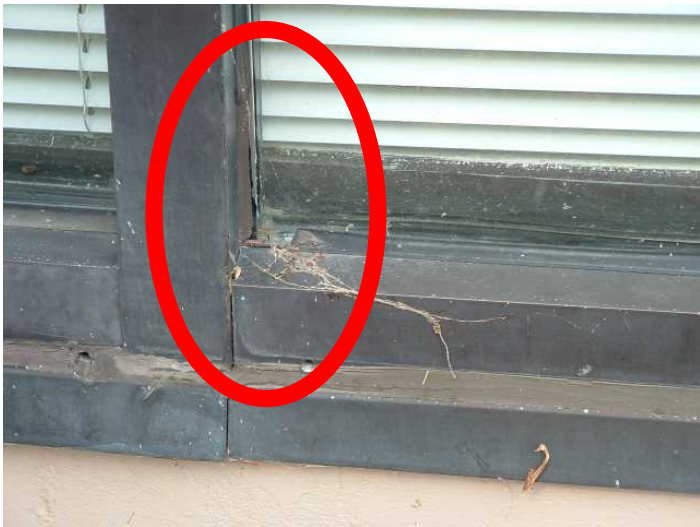
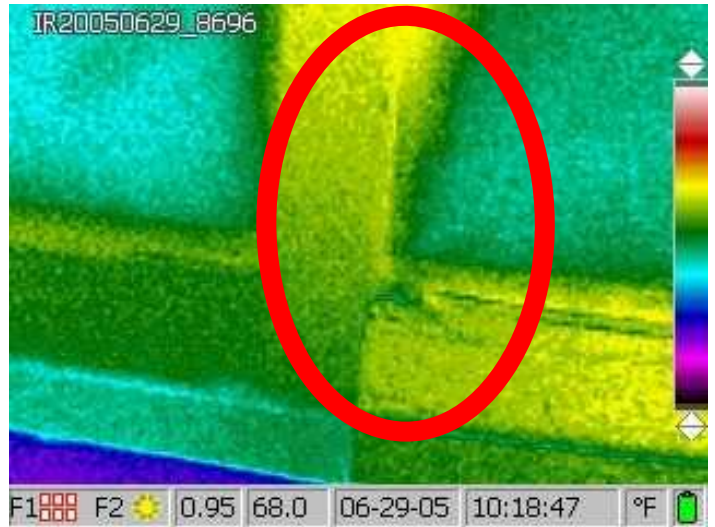
Observations:
Air infiltration appears to be indicated at mullion intersection as indicated with EZellipse marking

Location:Exterior - Orientation:Northwest - Delta Temperature:30 Degrees
Equipment: ThermalScan IRC-3000
Problem: Air infiltration appears to be indicated at mullion intersection as indicated with EZellipse marking

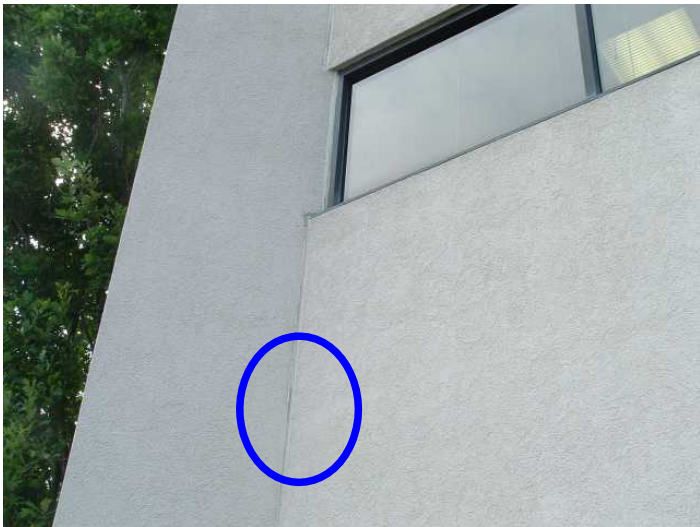
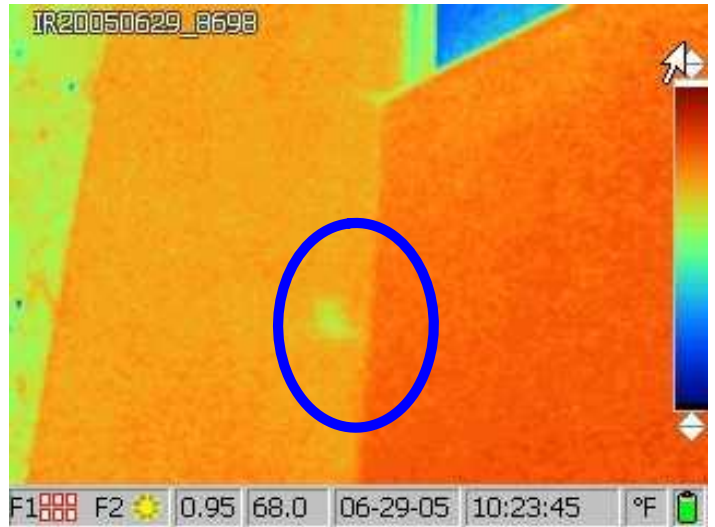
Observations:
Moisture appears to be indicated

Location:Exterior - Orientation:Northwest corner of structure - Delta Temperature:30 Degrees
Equipment: ThermalScan IRC-3000
Problem: Moisture appears to be indicated

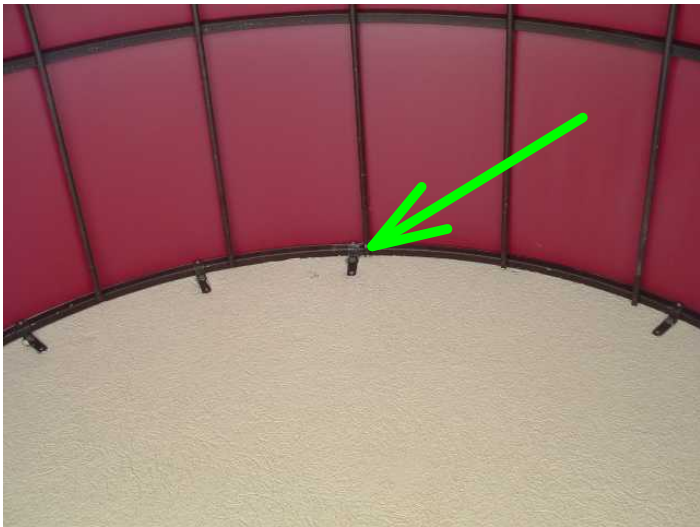
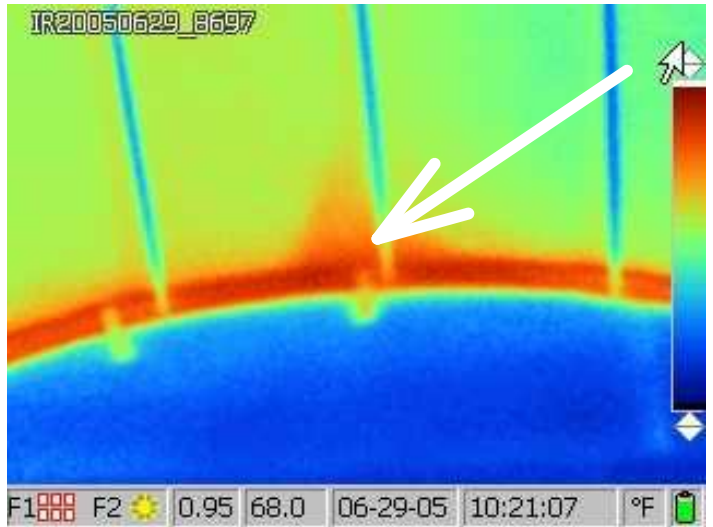
Observations:
Water intrusion confirmed with moisture meter reading of 108

Location:Entrance Awning viewed from underneath - Orientation:South - Delta Temperature:30 Degrees
Equipment: ThermalScan IRC-3000
Problem: Water intrusion confirmed with moisture meter reading of 108

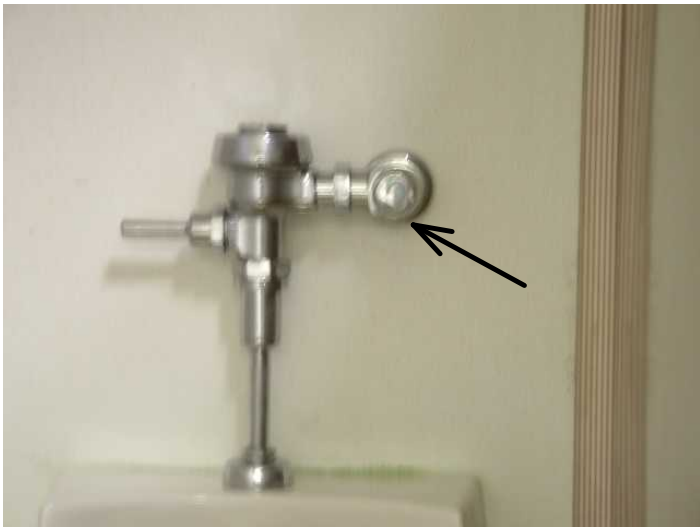
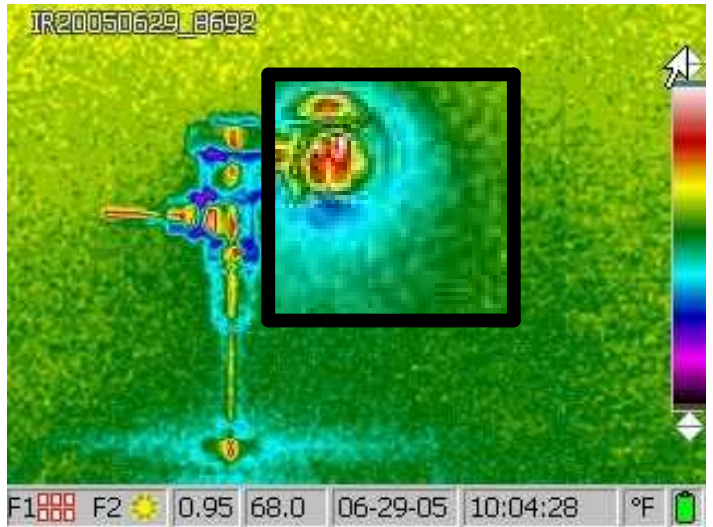
Observations:
Moisture appears to be indicated at urinal wall trim ring

Location:Interior - Orientation:South - Delta Temperature:15 Degrees
Equipment: ThermalScan IRC-3000
Problem: Moisture appears to be indicated at urinal wall trim ring

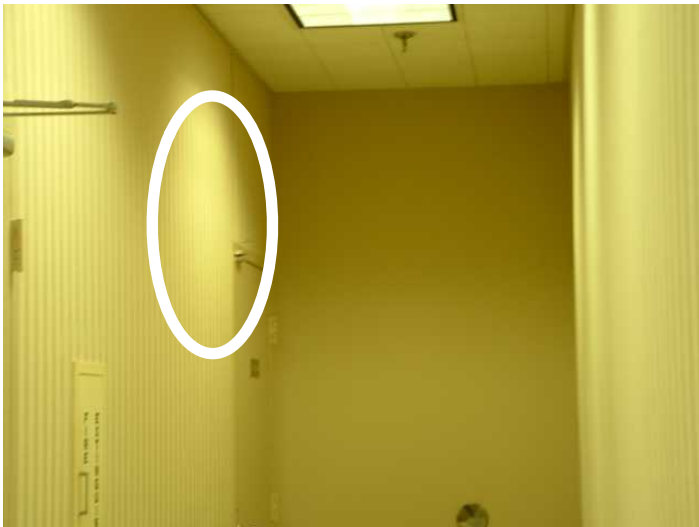
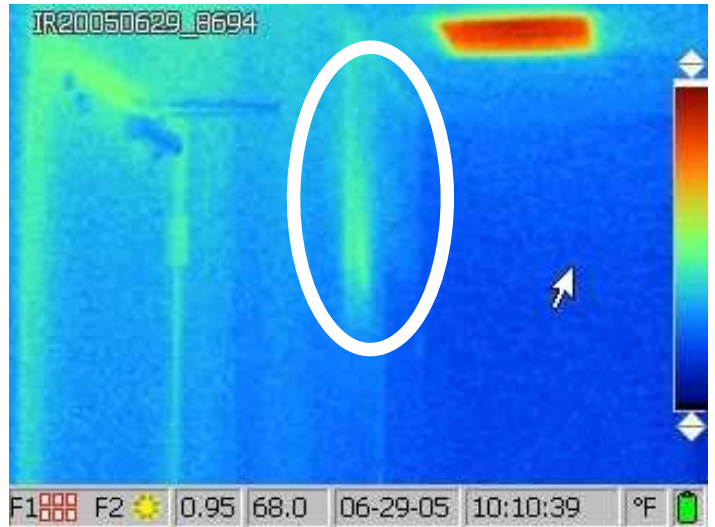
Observations:
Air infiltration appears to be indicated mid wall adjacent to Stairwall

Location:Interior - Orientation:East - Delta Temperature:15 Degrees
Equipment: ThermalScan IRC-3000
Problem: Air infiltration appears to be indicated mid wall adjacent to Stairwall

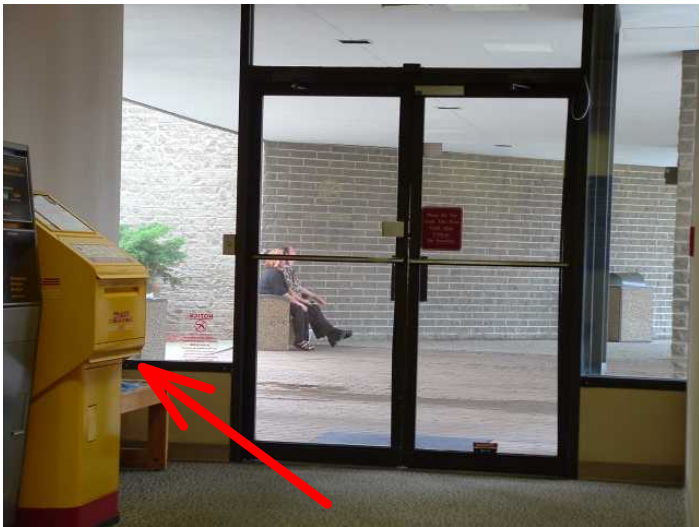
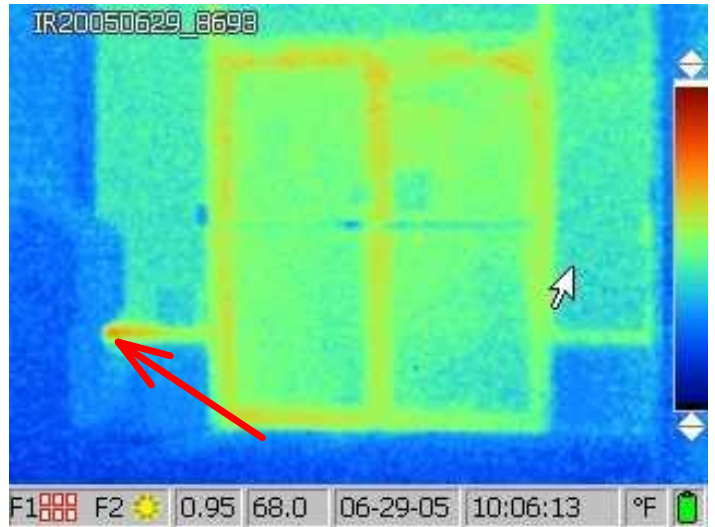
Observations:
Air infiltration appears to be indicated along Sill channel as noted by temperature difference

Location:Interior - Orientation:South Exit - Delta Temperature:15 Degrees
Equipment: ThermalScan IRC-3000
Problem: Air infiltration appears to be indicated along Sill channel as noted by temperature difference

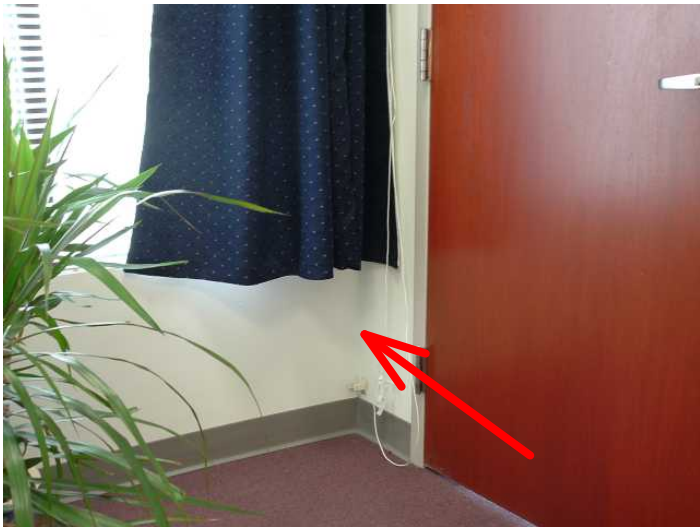
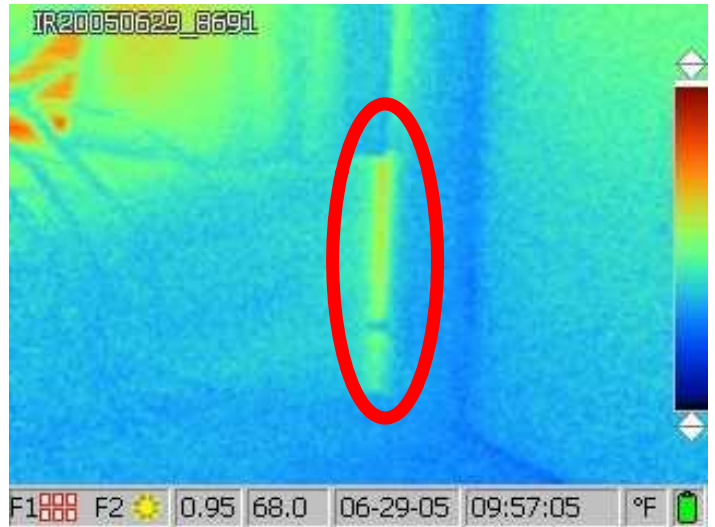
Observations:
Air infiltration appears to be indicated along exterior wall corner

Location:Interior - Orientation:East - Delta Temperature:15 Degrees
Equipment: ThermalScan IRC-3000
Problem: Air infiltration appears to be indicated along exterior wall corner

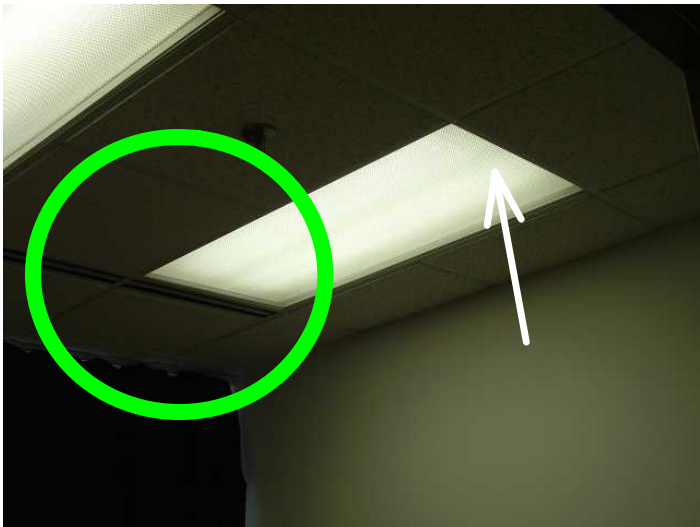
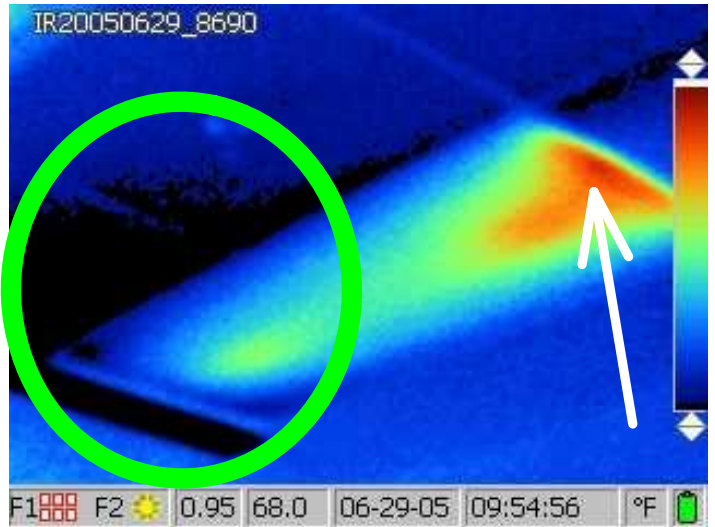
Observations:
Air infiltration appears to be indicated above ceiling around diffuser as marked with ellipse. Also noted possible electrical concern with flourescent fixture as noted with arrow

Location:Interior - Orientation:North - Delta Temperature:15 Degrees
Equipment: ThermalScan IRC-3000
Problem: Air infiltration appears to be indicated above ceiling around diffuser as marked with ellipse. Also noted possible electrical concern with flourescent fixture as noted with arrow
